* SAFETY INFORMATION NOTICE *

**Subject: Helicopter External Sling Load Operations, HESLO 1 – 4
 Helicopter Human External Cargo, HEC**

Information directed at	
Task specialists	Part M

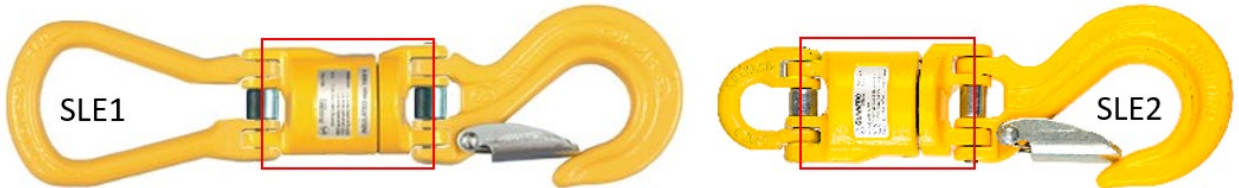
The original equipment manufacturer The Crosby Group/Gunnebo Industries reported that a limited number of SKLI swivels (fig. 1) may be missing a locking pin (fig. 2). The lack of this pin (fig. 3) cannot be seen from the outside and its absence cannot be positively determined by observation or by manipulation such as, for example, by firmly holding the upper part and simultaneously turning the bottom part clockwise (viewed from above).

Fig. 1a: SLE1 and SLE2, equipped with SKLI swivels (marked in red)

Identify all SLE1 or SLE2 products delivered by our company and remove them from aircraft service (blocked stock).

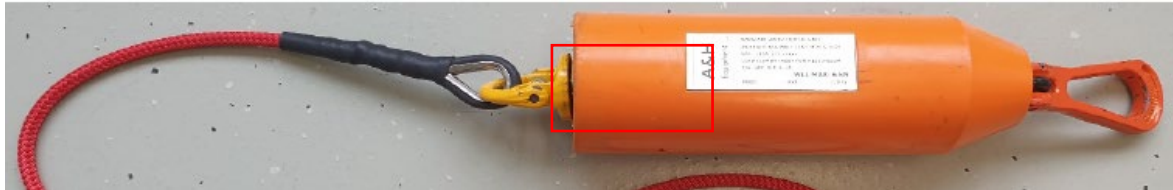
Fig. 1b: HEC_SLE_6x containing an SKLI swivel (marked in red)

Note: The operator of the HEC_SLE_6x component will be instructed by us directly.

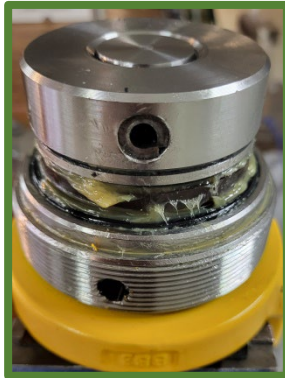
Fig. 2: Swivelling part with pin

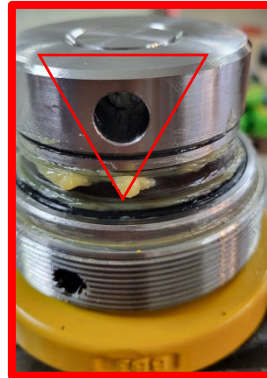
In the absence of the locking pin, the lower part can unthread counterclockwise (viewed from below), from right to left, and eventually back out of the upper part. Initially, this phenomenon is shown by a steady increase in the clearance between the upper swivel body and the lower jaw fitting (fig. 5). Unfortunately, a reliable examination is not possible since the lubrication inside the mechanism causes the anchor of the lower part to turn even without a pin connection. Once the shank is fully unscrewed, the load will get lost.

Fig. 3: Swivelling part without locking pin

We will open the parts and check their condition and functionality. If a correction should be necessary (insertion of a new pin) you will be informed. We will then send the parts back to you including a maintenance protocol and a release certificate.

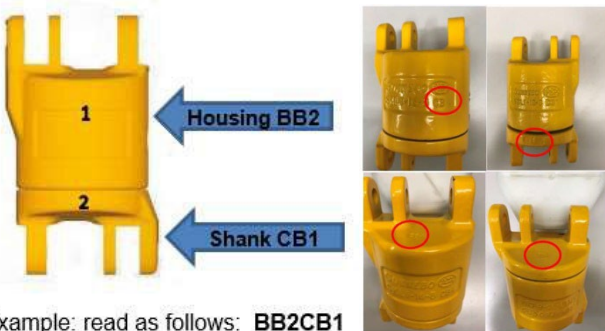
Fig. 4: Identification and coding

Since The Crosby Group/Gunnebo Industries stated that the notification only referred to specific deliveries (delivery notes) and specific batches (fig. 4), AirWork & Heliseilerei GmbH (A&H) checked these deliveries with their customers. Meanwhile, it has become clear that the information regarding the batches and the delivery notes in question cannot be correct, since none of the specified 3-digit embossings could be found. After having checked dozens of SKLI swivels, suppliers now believe that it must be assumed that all SKLI delivered between June 2021 and August 2022 could be affected, regardless their sizes (7/8 - 18/20).

Example: read as follows: **BB2CB1**

Identify each additional SKLI in your company to which the above criteria apply (delivery/first-time operation in the mentioned period) and remove them from service (quarantine store).

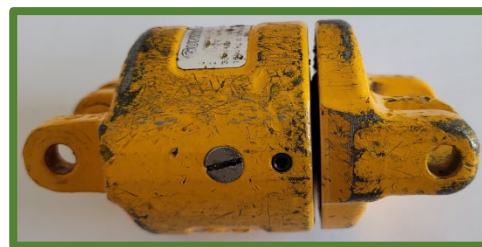
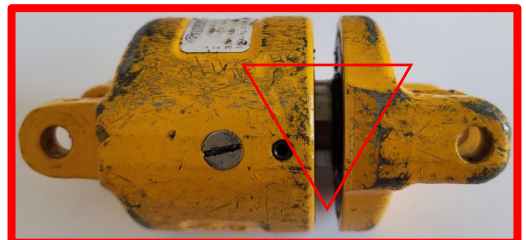
Fig. 5: Clearance between upper and lower part
