## Article by Aerossurance, LinkedIn May 26, 2024, Andy Evans

## HESLO R44 Snagged by its Own Longline (Synergy Aviation C-CGEC Oil & Gas Accident Alberta)

The Transportation Board of Canada ([TSB](#)) published their brief [safety investigation report](#) on 4 March 2024.

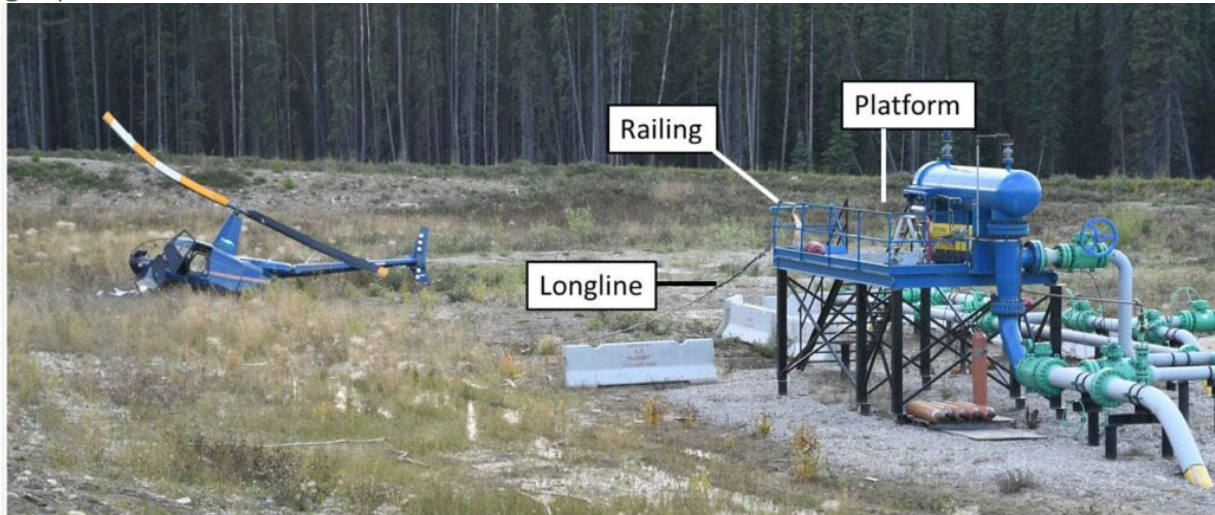
On 25 August 2023 [Robinson R44 C-GNEC](#) of [Synergy Aviation](#) crashed during a Helicopter External Sling Load Operation (HESLO) due to the longline being becoming entangled with gas production infrastructure.

Wreckage of Robinson R44 C-GNEC of Synergy Aviation at Gas Production Site (Credit: TSB)

*During the transition to forward flight, the helicopter did not respond to the pilot's flight control inputs. Unknown to the pilot, the longline had snagged a railing on the work platform.*

*As the pilot attempted to maintain control of the helicopter, the main rotor rpm began to decay. Given the likelihood of a crash, the pilot steered the helicopter away from the piping and tanks, subsequently colliding with terrain at 0931.*

- *All loads are to be set and removed from the ground adjacent but clear of the platforms.*
- *All lanyards with the spring latch systems are to be removed from service and replaced with a locked latch style hook with a manual release.*
- *All longline operations require the pilot to remove the aircraft door to ensure the best visibility of the external load and/or end of the longline.*
- *A review of all operations associated with the pilot operating contracts as well as site hazard identification.*

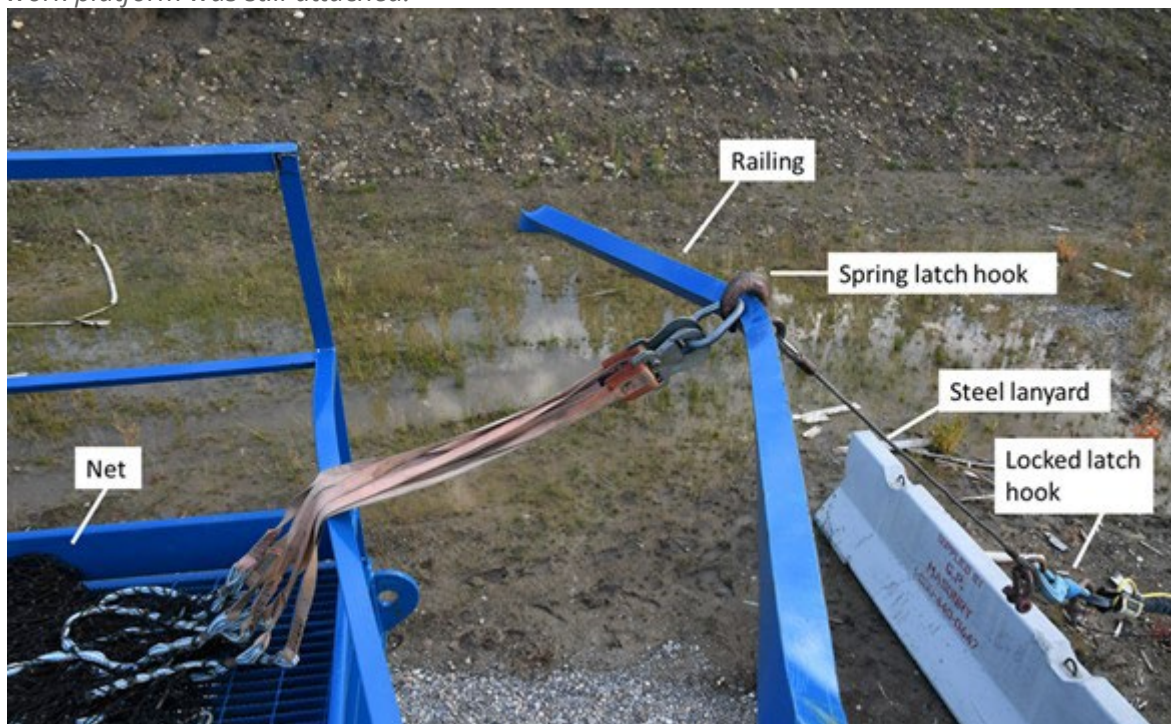
*When investigators arrived at the accident site, the lanyard that had snagged on the railing of the work platform was still attached.*

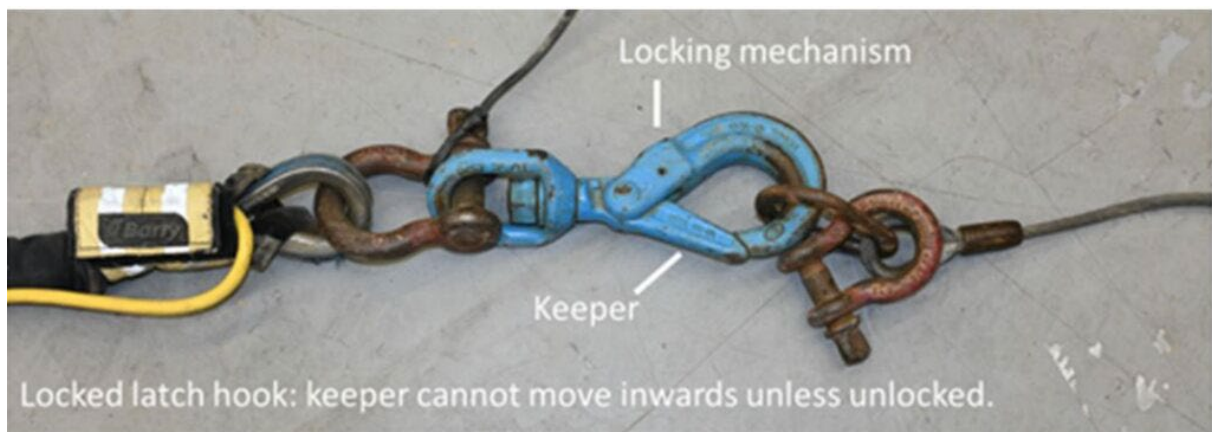
*The longline was equipped with a locked latch hook. This type of hook has a locking mechanism that prevents the hook's keeper from opening, which can mitigate the risk of snagging (top image).*

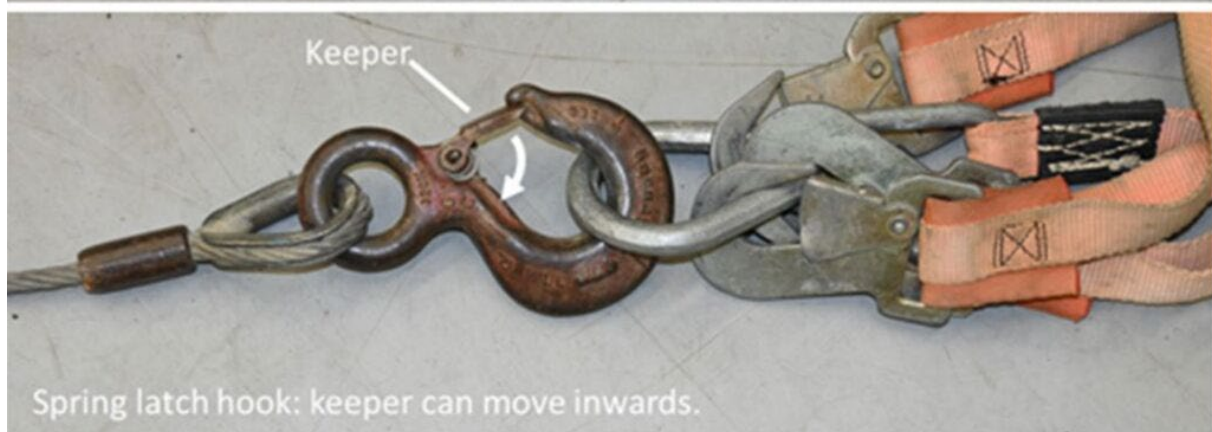
Then to the flight operations material. The LongLine was equipped with a safety hook, which is also supposed to be a swivel catcher. This is not a swivel (abuse)! Apart from the fact that the hook was attached to the LongLine with a shackle that had to be secured with a cable tie (the state of the art would be a Connex connector): why didn't he attach the blue safety hook directly into the eyelet on the net? The wire rope with the snap hook is unacceptable. There is also an unsecured and slightly open shackle on it.

*The end of the steel lanyard that was attached to the locked latch hook had a spring latch hook installed (bottom image).*

*This type of hook does not have a mechanism to prevent the hook's keeper from opening, and this is the hook that became snagged on the platform's railing.*

> procure LongLine equipment that meets the state of the art and the requirements for safe helicopter operations.
